# Manhole Inspection Summary

Manhole # S61K\_\_022MH

Insp Date: **3/21/08 10:21 AM**

**Location** Address: **830 Rappolla St.**

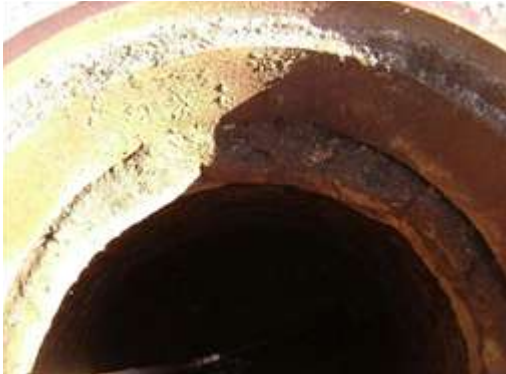
Defect 1

Offset: **1** (in.)

frame offset

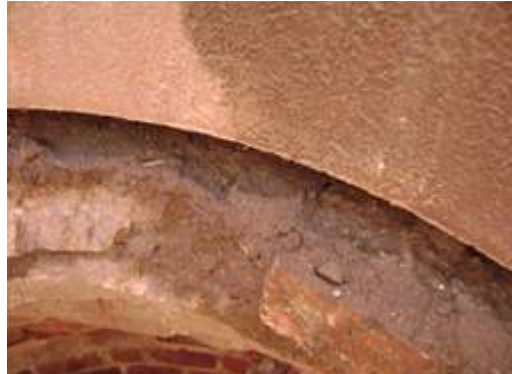
Defect 2

Condition: ☐ Sound ☐ Cracked ☐ Root Intrusion ☒ **Loose Brick** ☒ **Deteriorated**

Infiltration: ☐ None ☐ Joint ☐ Cracks ☒ **Mortar** ☐ Roots ☐ Wall

Gap between frame and chimney

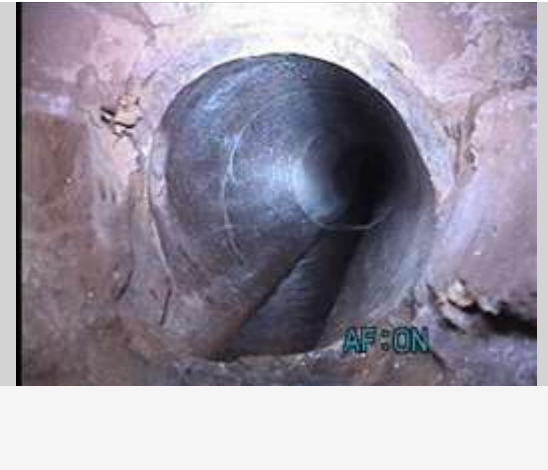
9 O'Clock Inflow

Comments **ADD DEFECT FOR CIRCUMFERENTIAL CRACK IN THE INCOMING 9 O'CLOCK**
